September 22, 1977

**GEORGE C. MARSHALL SPACE
FLIGHT
CENTER**

FAILURE ANALYSIS
OF
STRUTHERS - DUNN
S2GP-7.25-73D
RELAY

ELECTRONIC PARTS VERIFICATION BRANCH
ELECTRONICS DEVELOPMENT DIVISION
ELECTRONICS AND CONTROL LABORATORY

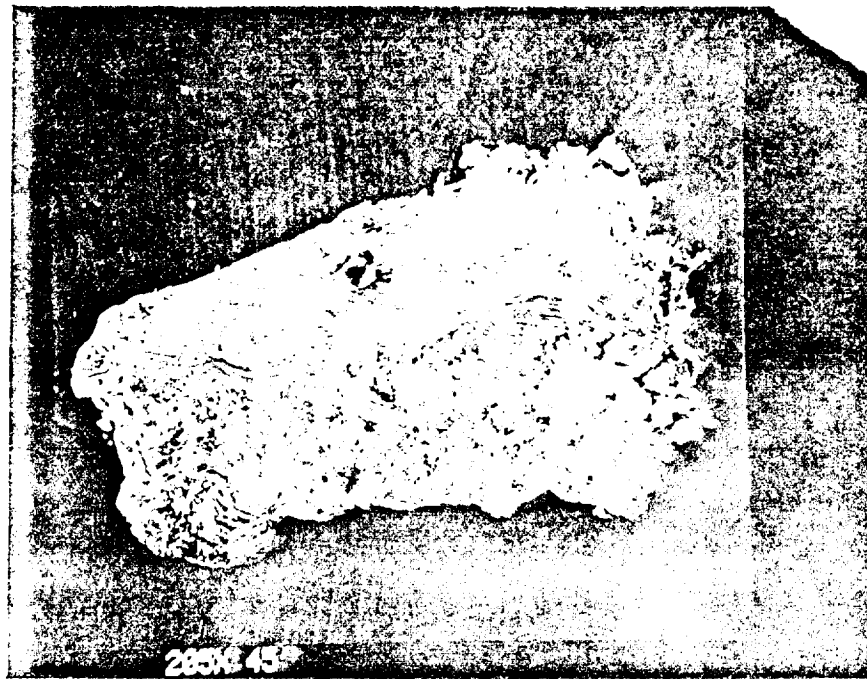
The particles were examined with the scanning electron microscope and an EDAX analysis performed. It was determined that the primary constituents of the particles were iron and nickel. Figures 4, 5, 6 and 7 show the particles and the EDAX results. Because of the irregular surface of the particles, it was concluded that they were most probably generated from welding operation during assembly of the relay. Through further analysis, it was determined that the same materials were used in the pole piece and backstop; therefore, it was further concluded that the particles were most probably generated during welding this assembly. Figures 8, 9, and 10 show the pole piece-backstop assembly and the EDAX results of each.

Figure 4. Large Particle from Relay (205X)

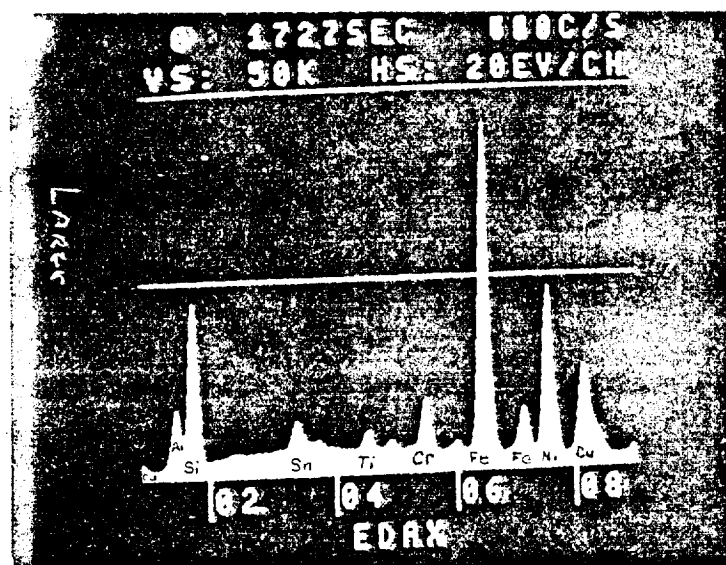
Figure 5. EDAX Analysis of Large Particle

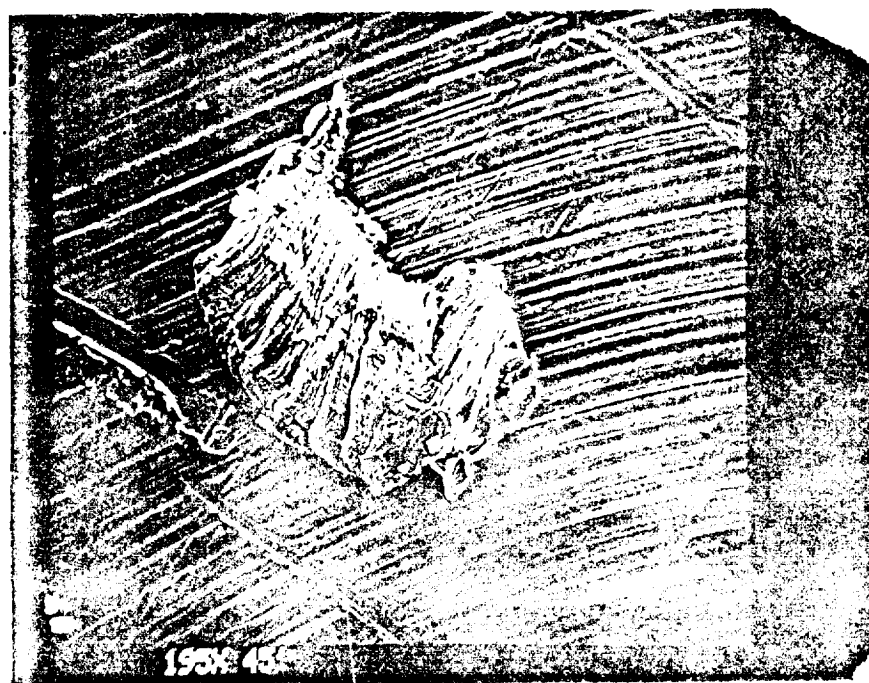
Figure 6. Small Particle from Relay (195X)

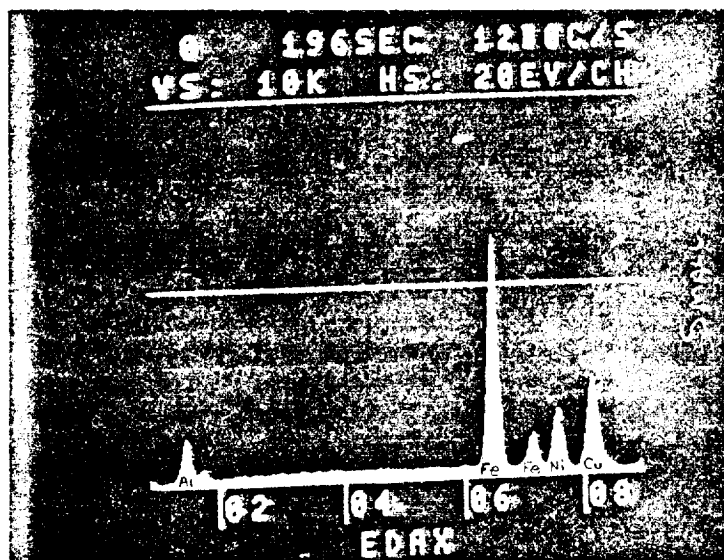
Figure 7. EDAX Analysis of Small Particle

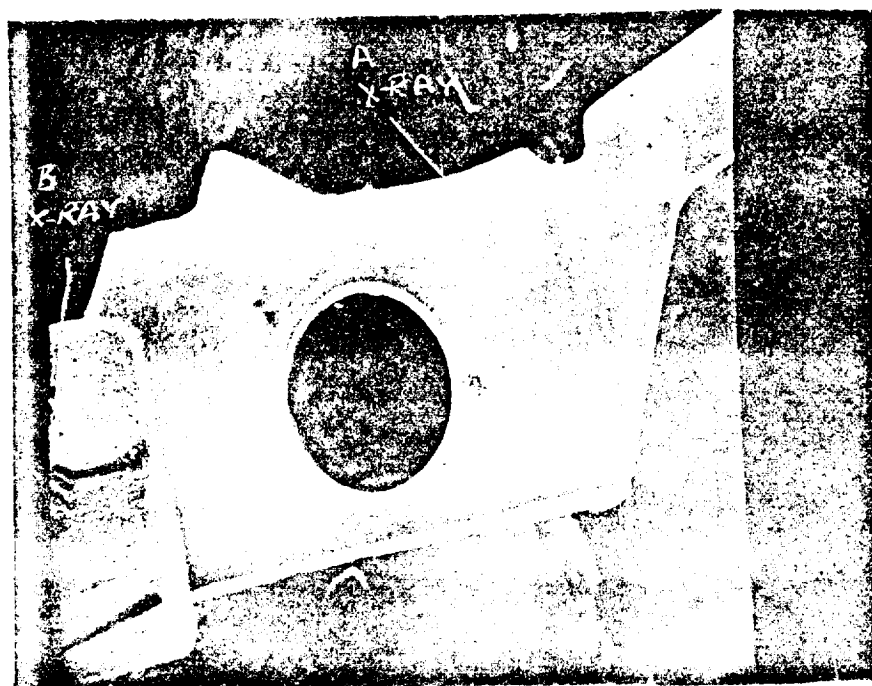
Figure 8. Pole Piece and Backstop Weld Connection

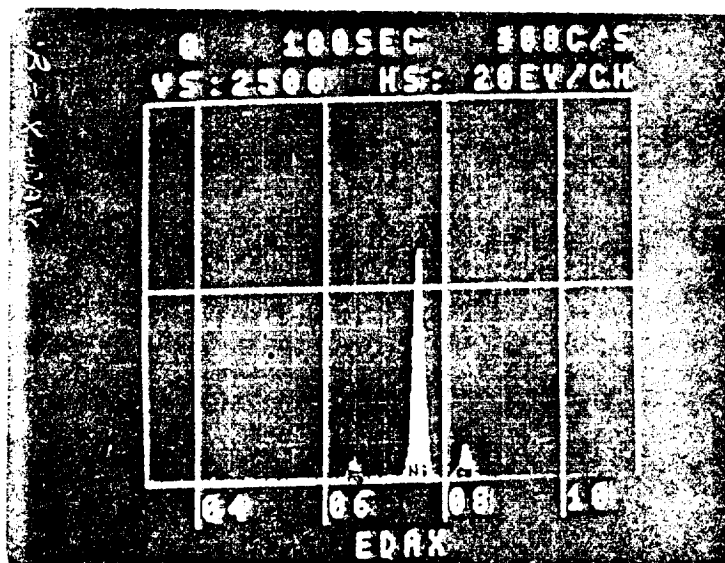
Figure 9. EDAX Analysis of Pole Piece

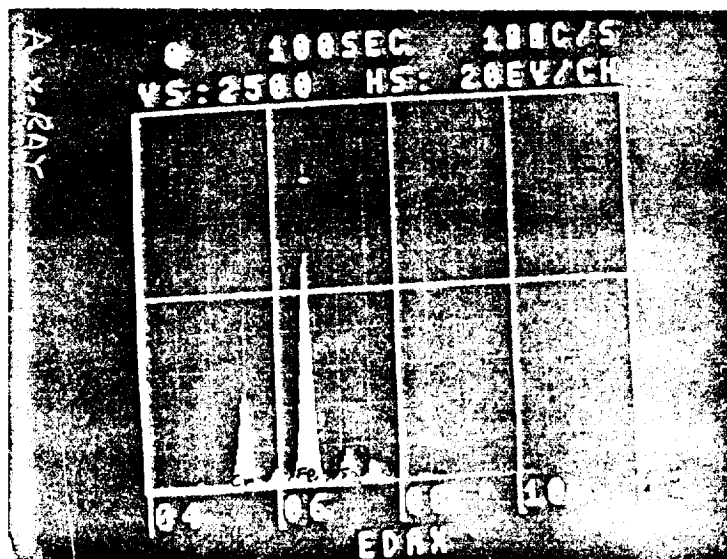
Figure 10. EDAX Analysis of Backstop

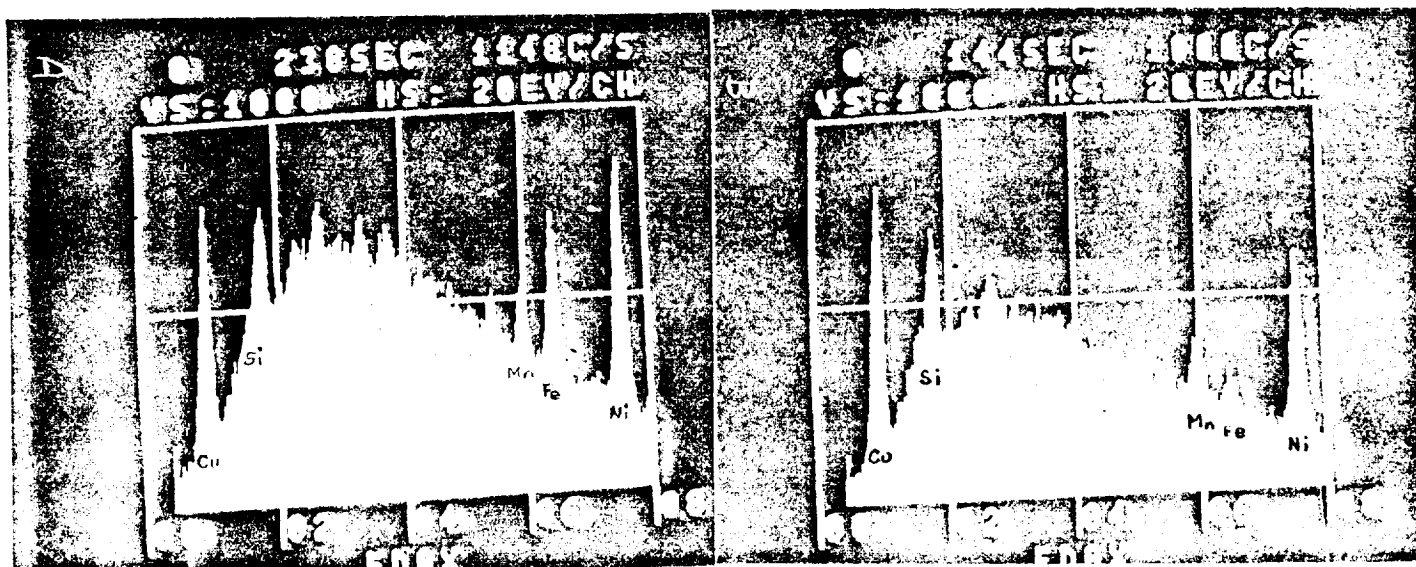
Another observation made during the microscopic examination was improper weld of the coil lead to pin 19. This is shown in figure 11. Figure 12 shows the opposite coil lead attached to pin 20. This was a good connection. The coil lead from pin 19 was straightened so that the pin contact area could be observed. Figure 13 shows this area. An EDAX analysis was performed in two places in the contact area as shown in figure 13, with the results shown in figure 14, and a reference analysis on the back of the lead at the contact area as shown in figures 15 and 16. There was no indication of pin material in the pin contact area indicating that the lead had not been properly welded to the pin.

Figure 14. EDAX Analysis of Coil Lead at Pin
Contact Area (Pin 19)

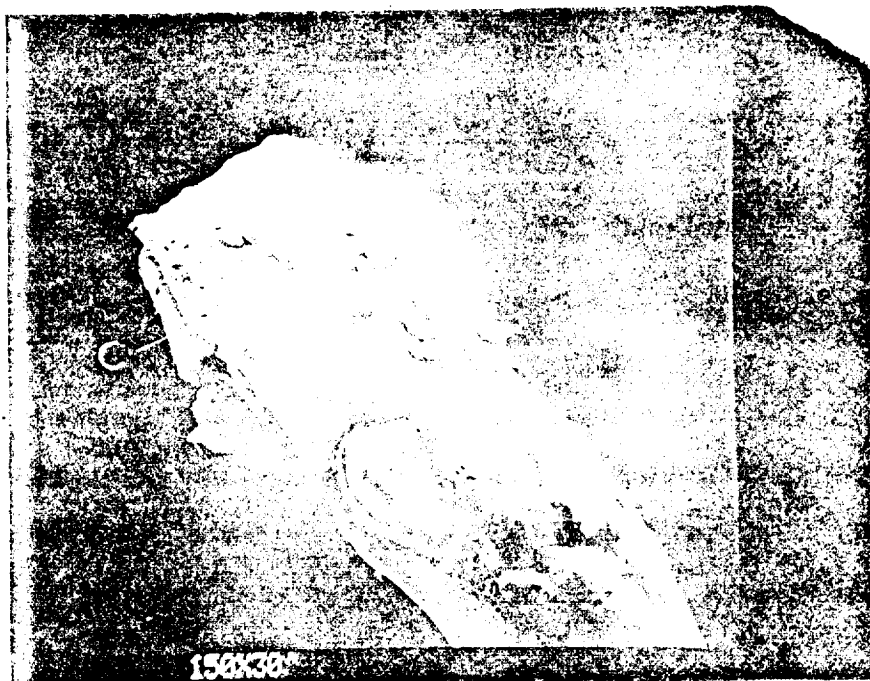
Figure 15. Coil Lead on Back Side of Pin Contact Area (150X) (Pin 19)

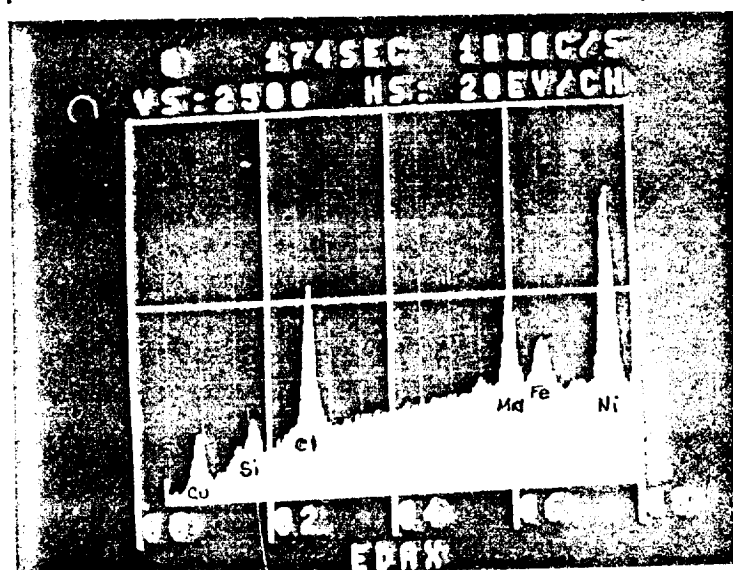
Figure 16. EDAX Analysis of Coil Lead on Back Side of Pin Contact Area (Pin 19)

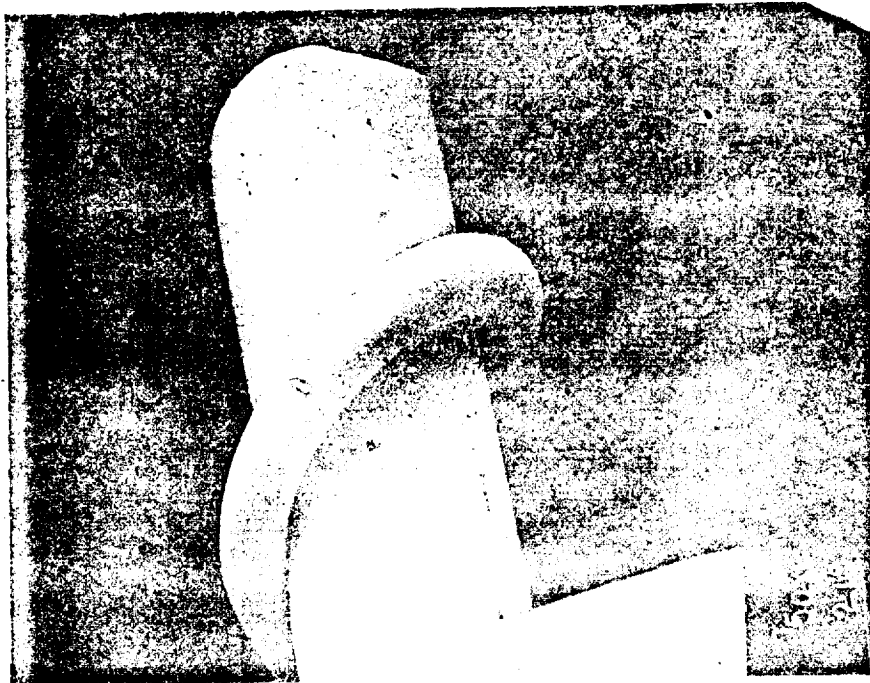
The other coil lead and pin 20 were removed from the relay to observe the weld. Figure 18 shows the pin and lead prior to removal and figure 19 shows the lead-to-pin weld. Upon pulling the coil lead from the pin, the lead broke at the heel of the weld as expected, indicating good weld penetration.

Figure 18. Pin of Opposite Coil Lead
(50X) (Pin 20)

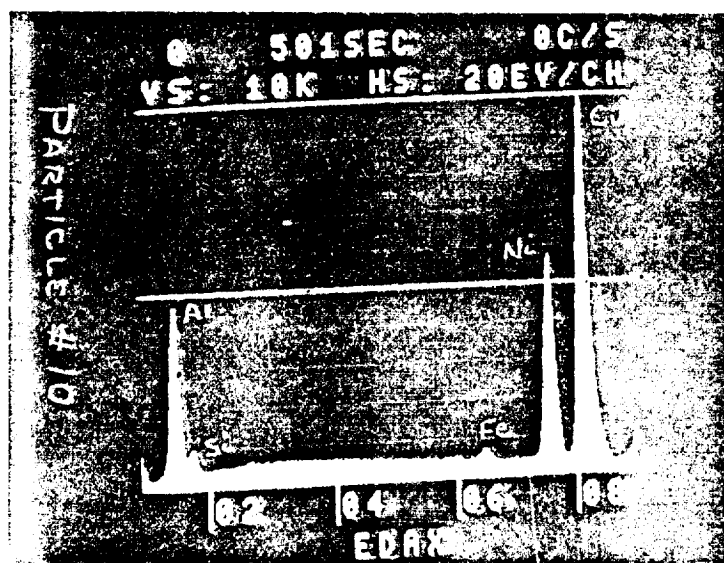
Nineteen additional relays from this lot were examined and further analyzed to determine if the anomalies observed in the failed relay were lot oriented. Figure 20 shows scratches inside the case of serial number 10. A particle was observed in this relay attached to the inside top of the case. This particle is shown in figure 21 and the EDAX results are shown in figure 22. It was determined that this particle was the same material as the case and was generated when the case was fitted to the relay assembly.

Figure 22. EDAX Analysis of Particle from
Relay, S/N 10

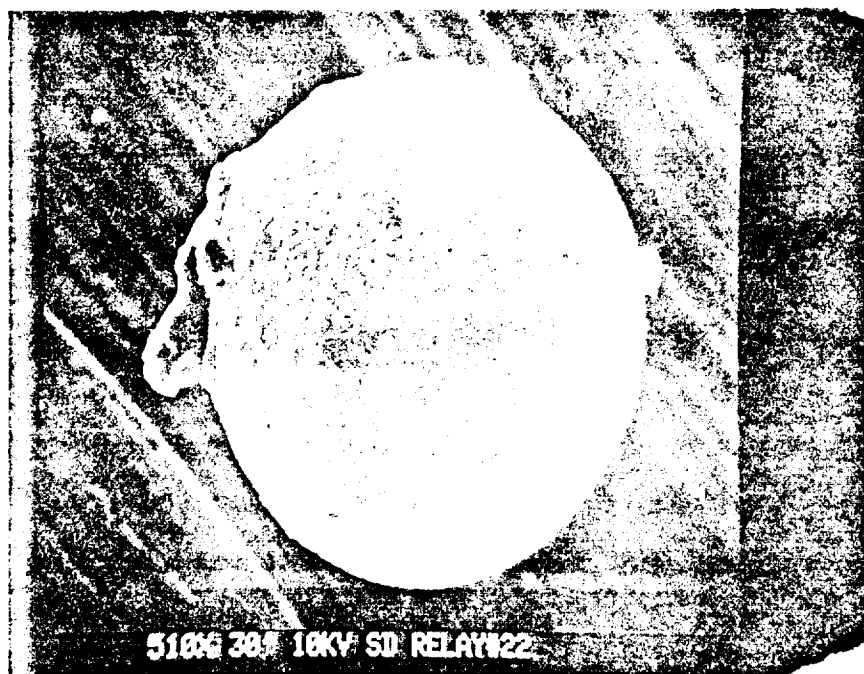
Figure 25 shows the particle and figure 26 is the X-ray spectrum.

Figure 25. Particle from Relay, S/N 22, Armature

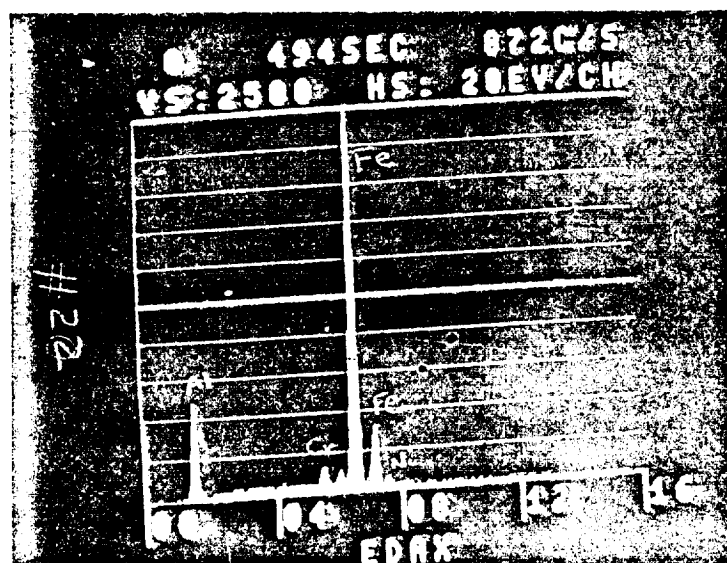
Figure 26. EDAX Analysis of Particle from Relay, S/N 22, Armature

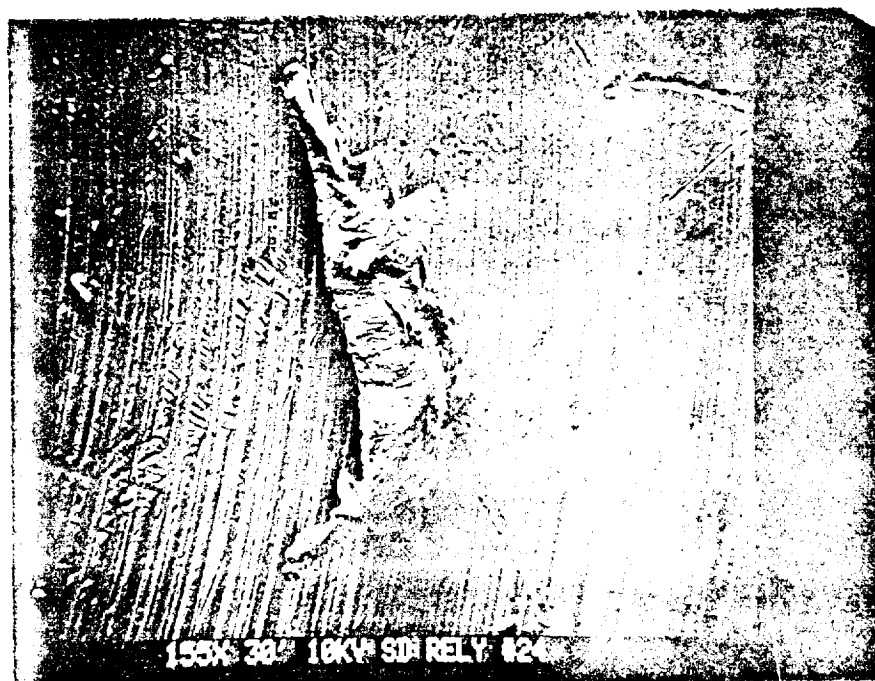
Figure 28 shows the copper particle and figure 29 is the X-ray spectrum.

Figure 28. Particle from Relay, S/N 24 (155X)

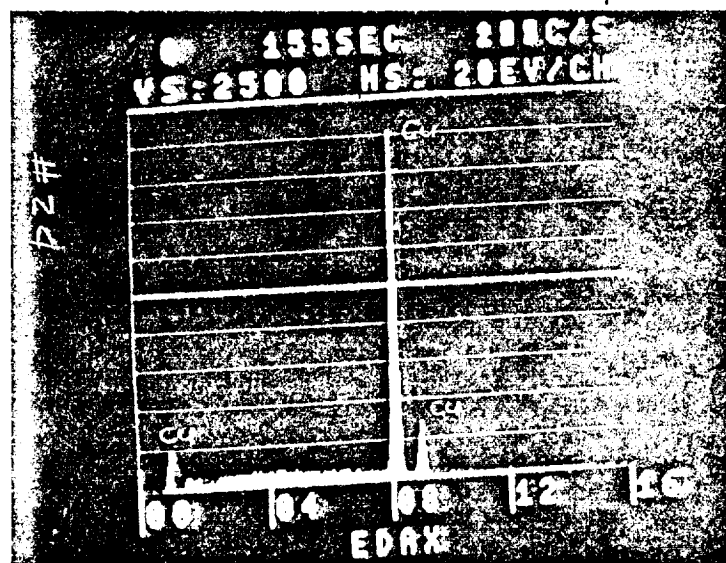
Figure 29. EDAX Analysis of Particle from Relay, S/N 24

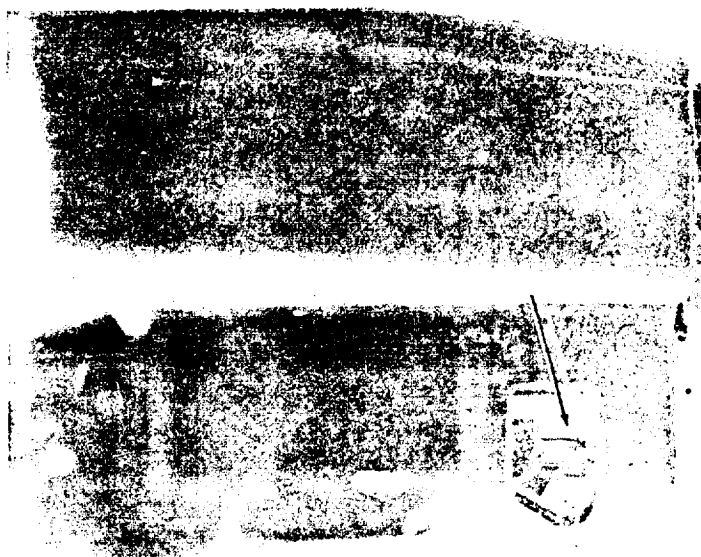
| Serial No. 24 | <ol style="list-style-type: none">1. Copper colored particle in top of case, not attached, figure 272. Small non-metallic particles in case, figure 273. Metallic particles magnetically held to pusher, figure 30 |

Figure 30. Relay, S/N 24, Assembly Showing Magnetic Particles on Pusher

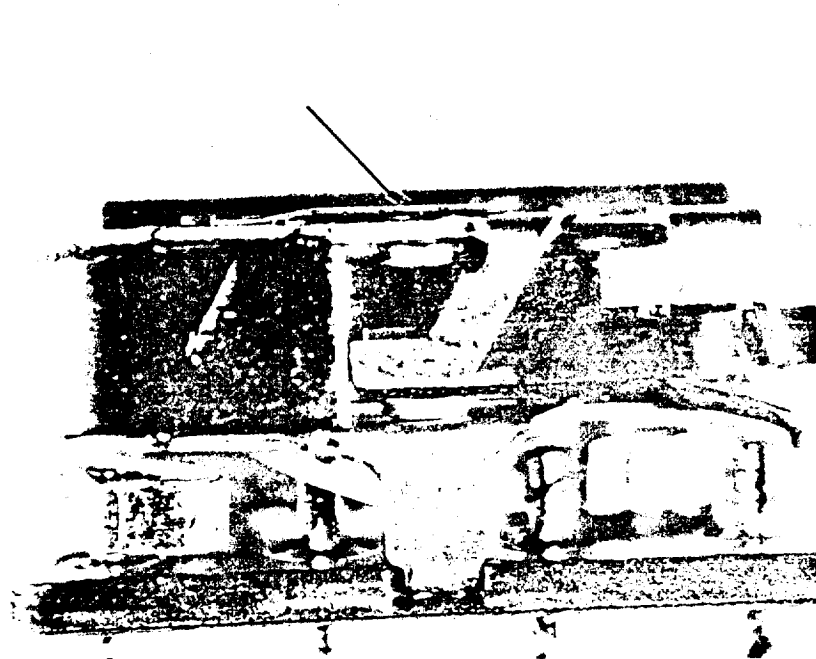
| Serial No. 45 | <ol style="list-style-type: none">1. Numerous non-metallic particles in case, including one fiber approximately 3/4 inch long, figure 322. Armature very loose with excessive end play. The spring was not contacting the armature pivot bearing, figure 33 |

Figure 33. Relay, S/N 45, Assembly Showing Lack of Pivot Bearing Spring Contact and Excessive Armature Pivot Bearing End Play
